Removal of Interior Door Trim

Ferrari 348 GTS '94 Euro Model LHD

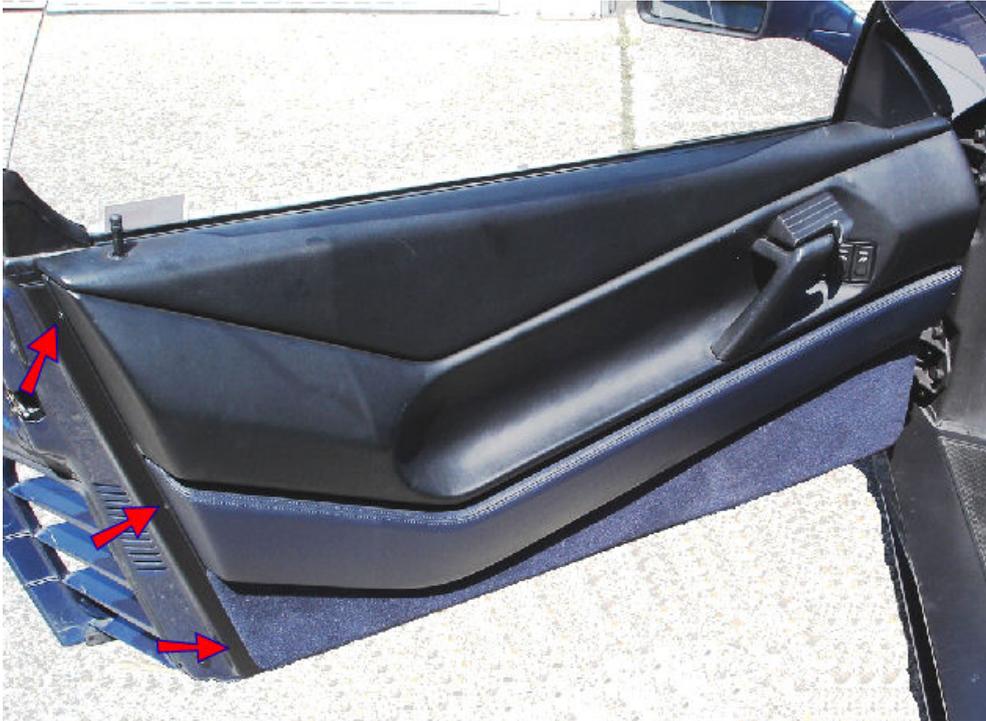
Figure 1

1. Remove 3 long self-tapping philips head screws together with their cup washers from the rear of the door. See Figure 1.

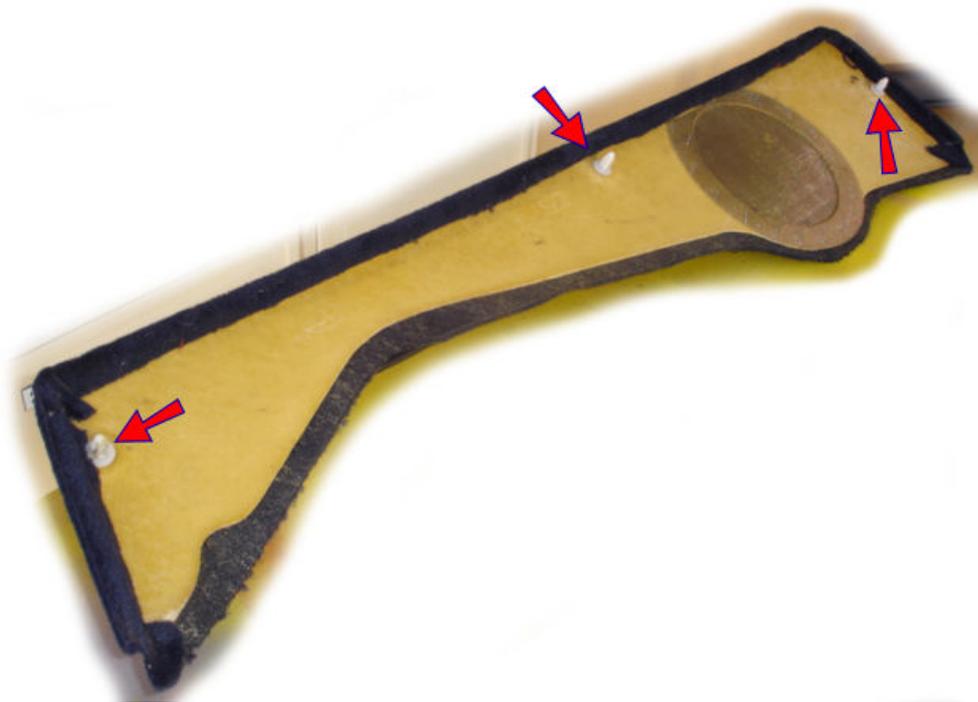
Figure 3

4. Unclip the lower section D by prising it gently loose from the door. If necessary, use a wooden slat to assist. A wooden frying pan spatula is ideal. This section is retained with 3 push in plastic clips. See Figure 3.

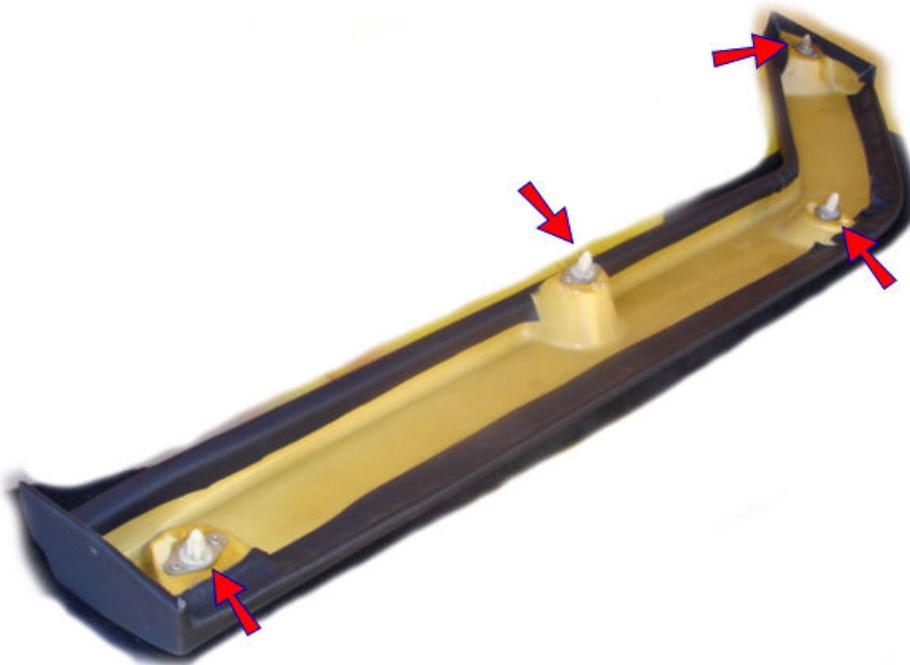
Figure 4

5. Unclip the leather covered section C by prising it gently loose from the door. This section is retained with 4 push in plastic clips. See Figure 4.

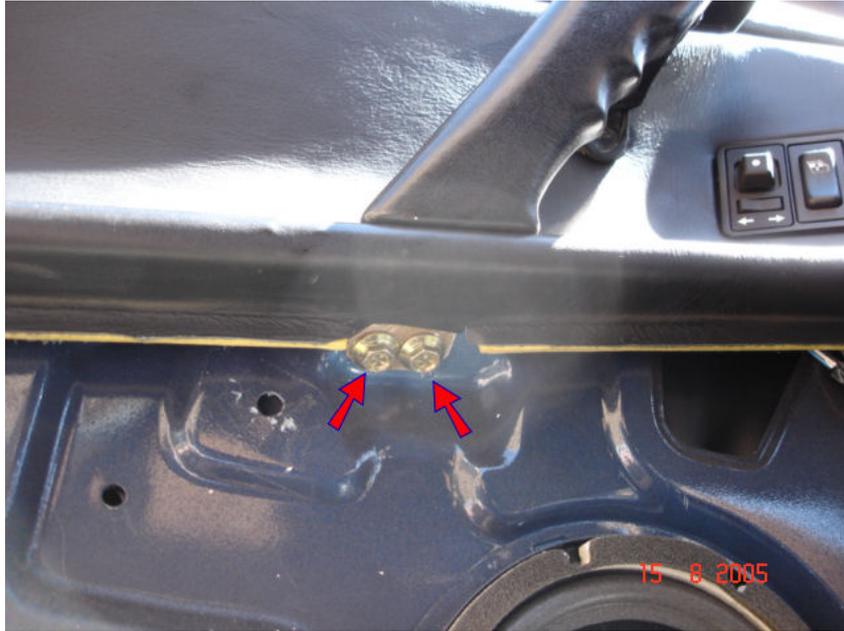
Figure 5

6. Remove inner door grab handle. This is retained with 2 M6 bolts (see Figure 5) and 1 black Philips head bolt. The M6 bolts may be very tight. When all bolts are removed, gently extract the handle upwards and out of the trim section. This operation is slightly eased if the door catch release is already loosened.

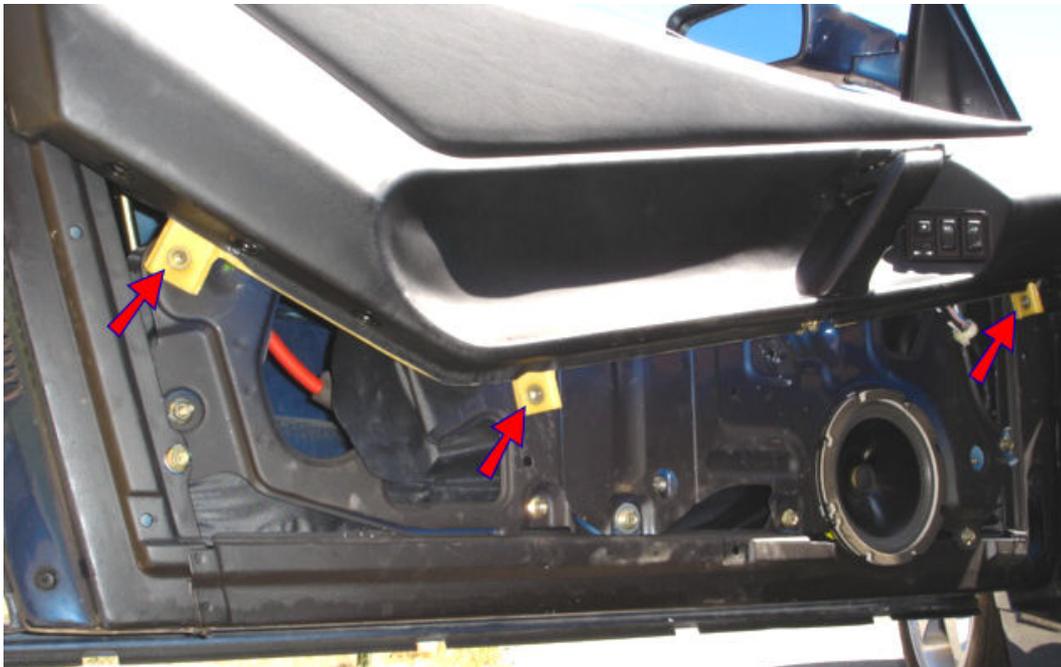
Figure 6

8. Remove the 3 large Philips head self-tapping screws (see Figure 6) from the lower edge of trim B. Unclip the trim (1 clip at rear, 1 clip at front see Figure 7) and extract by sliding slightly forward so that it clears the front retaining tongue. Unclip wiring loom (Figure 8) from door window /door mirror switch.

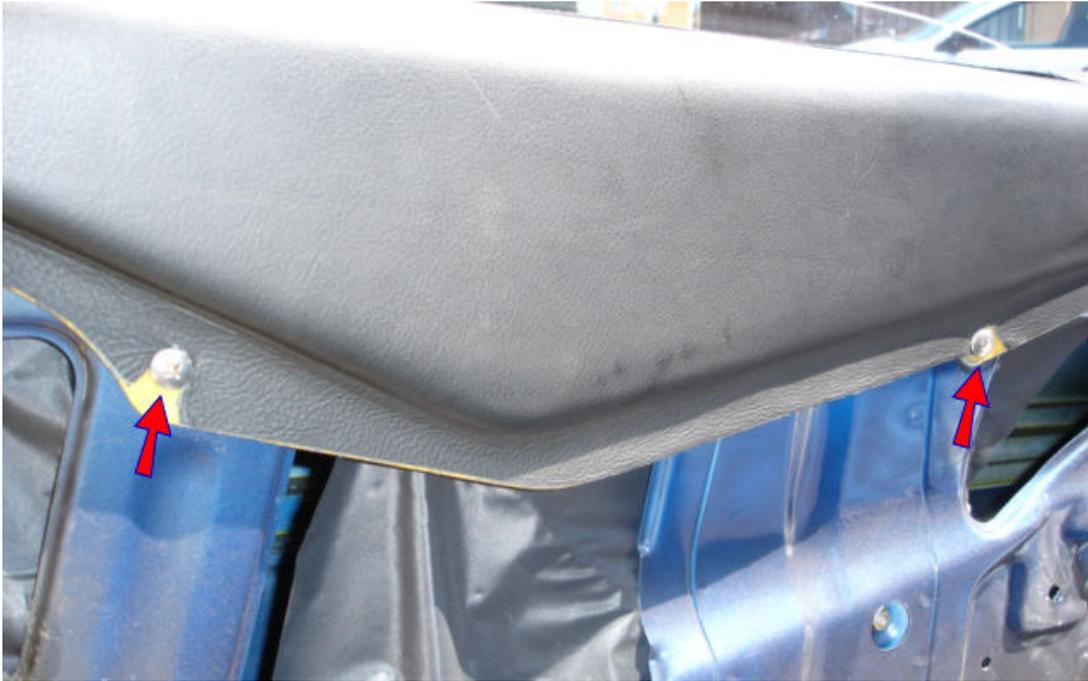
11. Remove the 2 large Philips head screws retaining the top trim and carefully lift away. See Figure 9
